TECHNICAL NOTE

D-1239

AN EXPERIMENTAL STUDY OF THE EFFECT OF DOWNWASH
FROM A TWIN-PROPELLER VTOL AIRCRAFT ON
SEVERAL TYPES OF GROUND SURFACES

May 1962

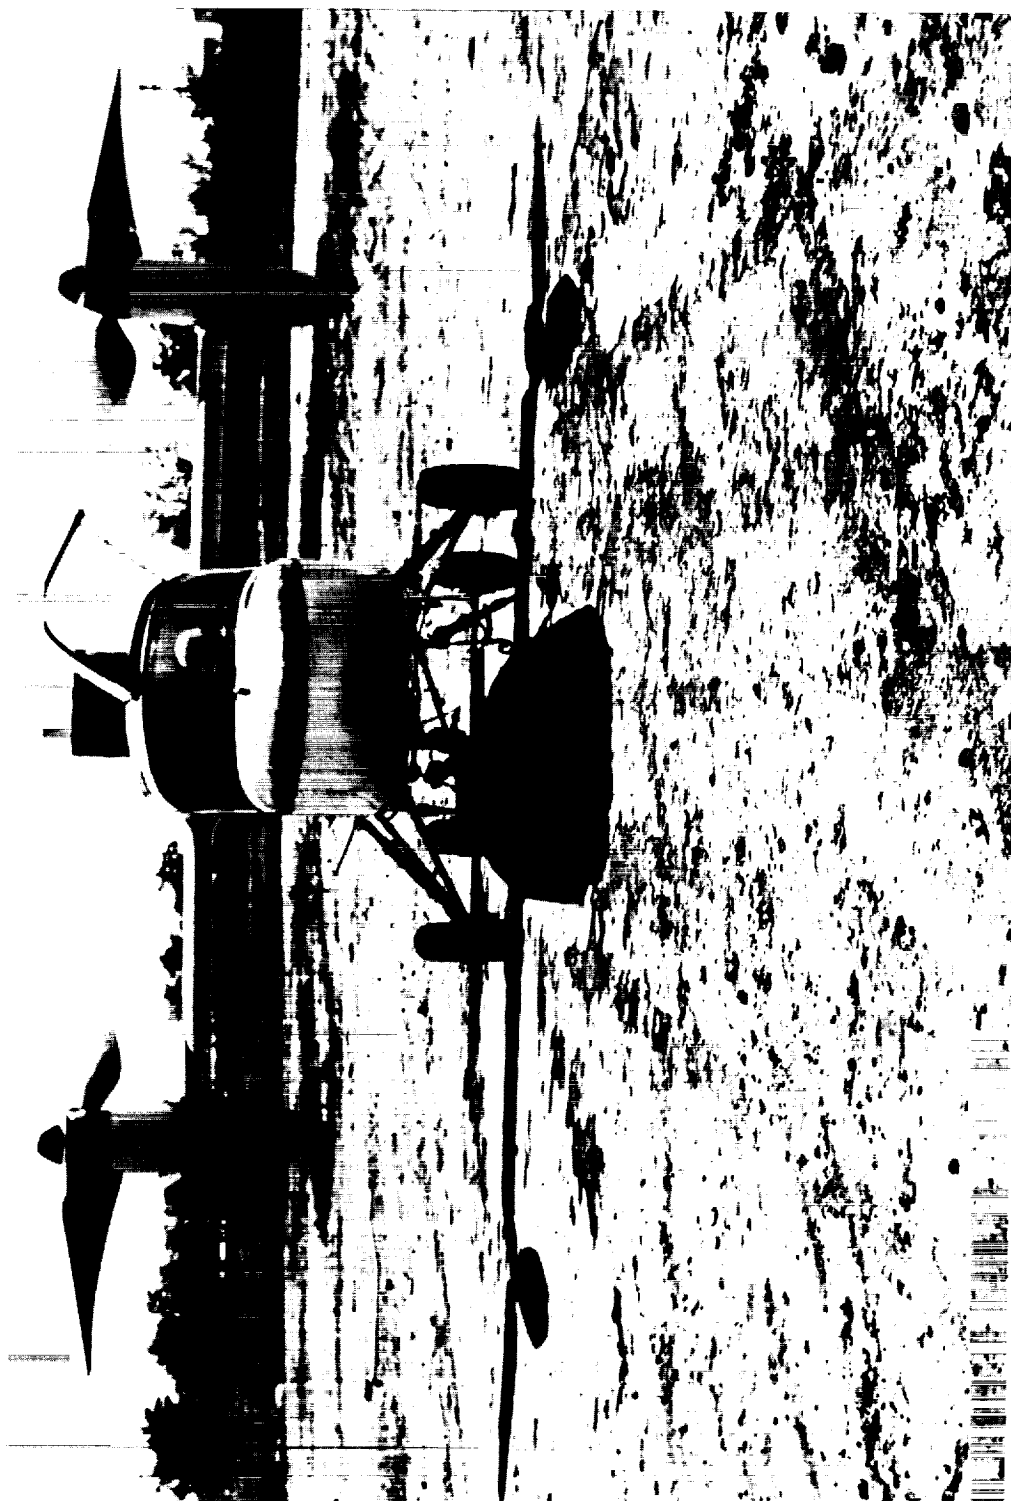
(b) Photograph of typical areas of ground surface peeled away by downwash.
I-61-3494

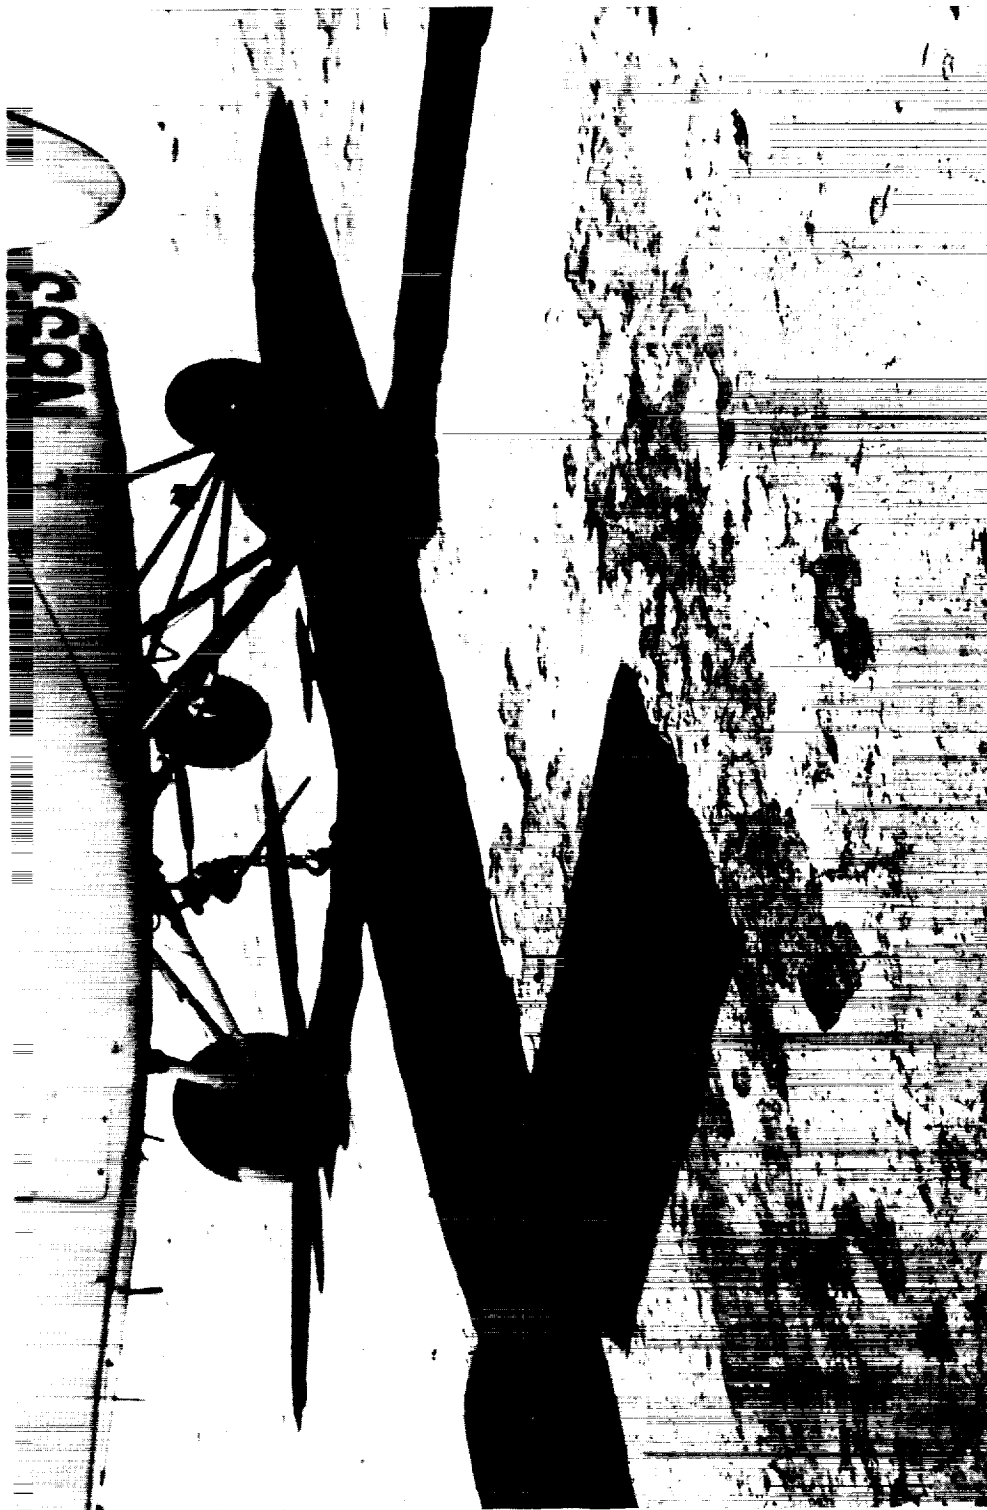
(c) Closeup view of typical peeling of surface.

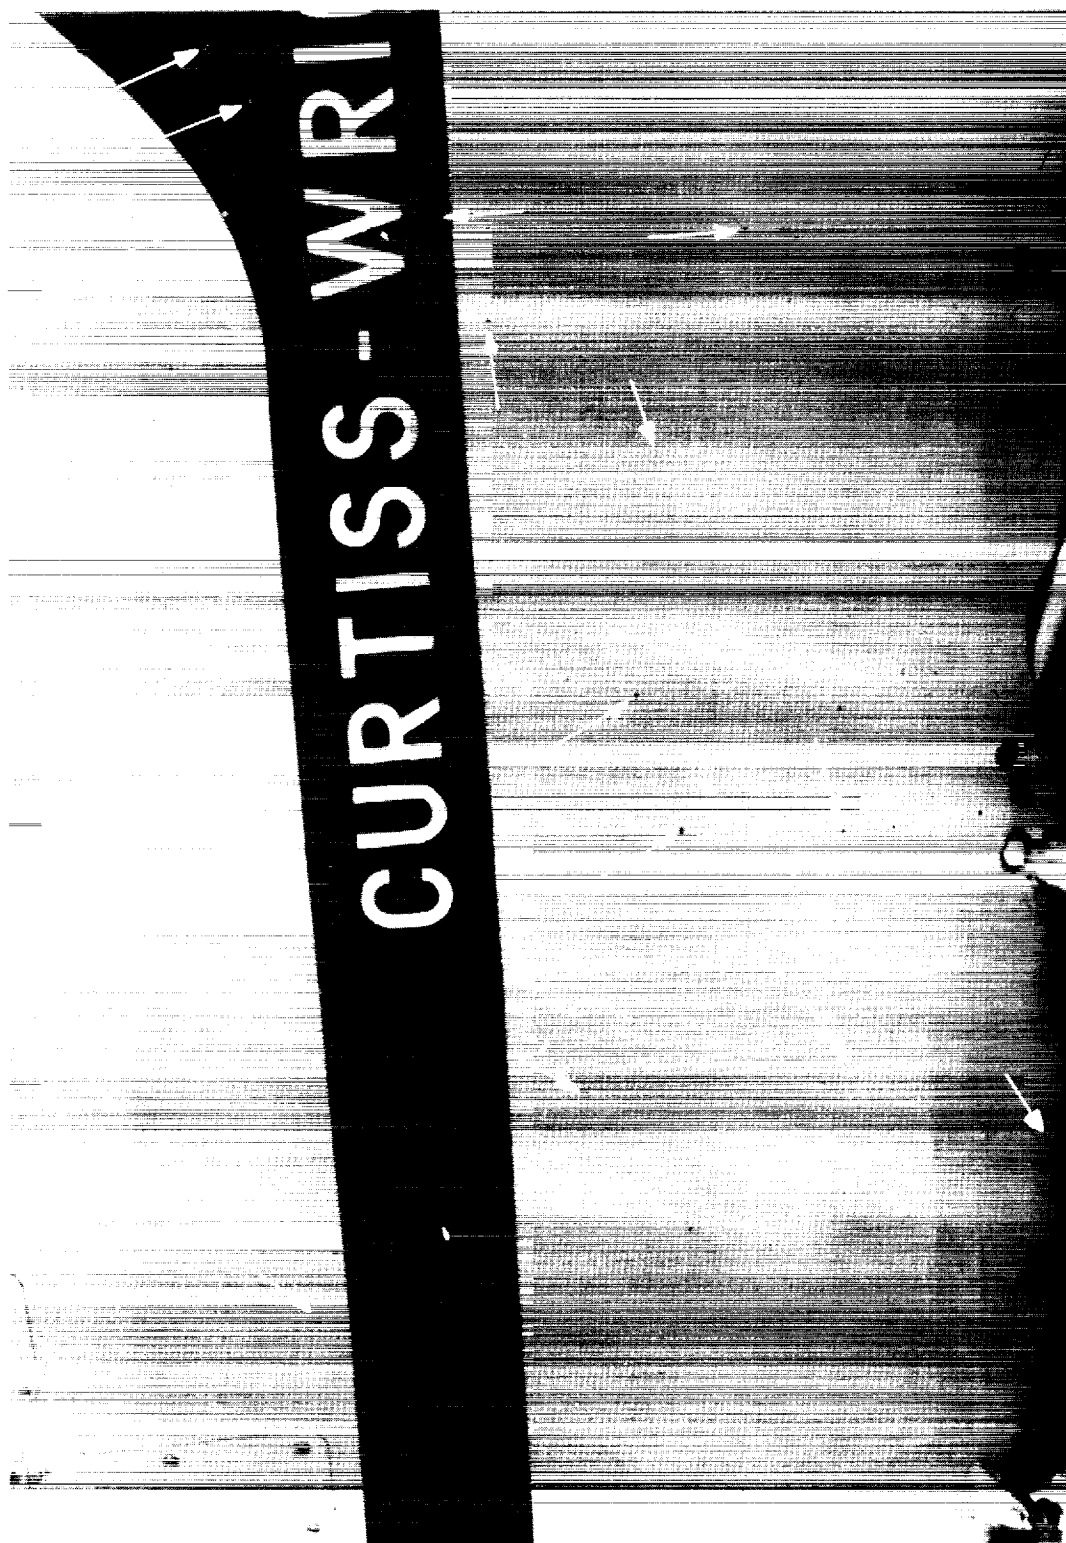
The area of the fuselage subjected to impact from the gravel was determined from holes in fabric and from paint removal and dents in metal areas. The extent of the area of maximum damage was approximately the lateral projection of the slipstream on the fuselage. A view of the fuselage in this area is presented in figure 10. The condition of the impacted surface indicated that the gravel struck with a flat horizontal trajectory normal to the fuselage, except for isolated impacts near the nose and tail that indicated a trajectory nearly parallel to the ground at a shallow angle with respect to the fuselage side.

Figure 10.- Photograph of damage to side of fuselage from movement of gravel.
L-61-4754
